St. Andrew's Church

Individual Landmark

2067 Fifth Avenue

Designation Date: April 12, 1967

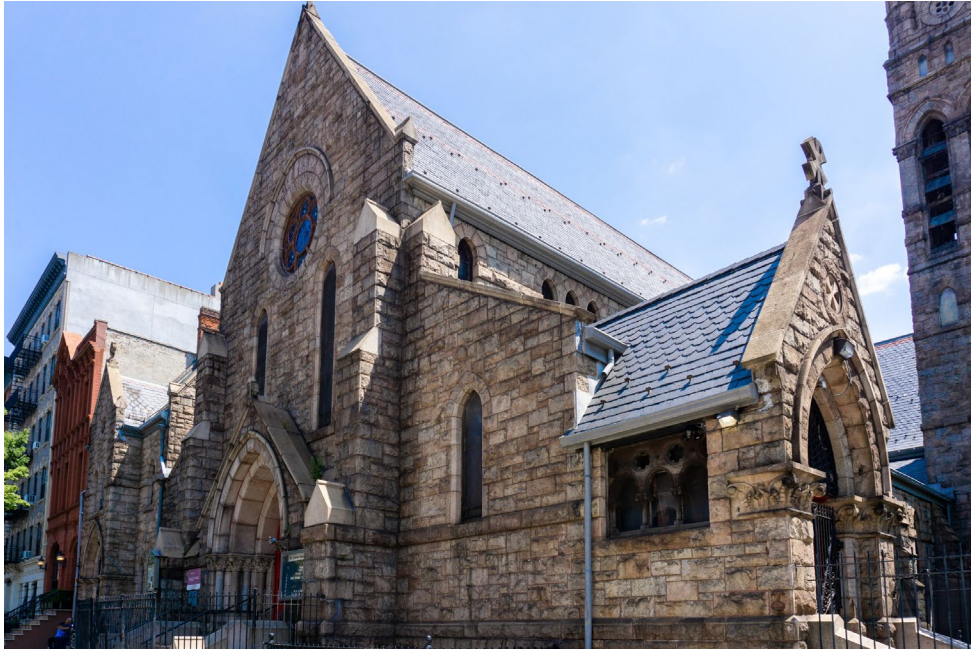
St. Andrew's Church. Photo: Lorraine Colbert

The architectural composition of Saint Andrew's Church is distinctive and picturesque in the Gothic manner. Constructed of rock-faced granite, the church's rugged appearance has a solid quality and great dignity. The interesting massing of structural elements culminates in a handsome clock tower, adjacent to the south transept on East 127th Street. Two graceful pointed-arch openings on each side of the belfry give form a deep shadow to the tower, while the slate-covered spire is adorned at each corner by delicate turrets. Cruciform in shape, the plan has galleries in the transept and side aisles in the nave. Simple buttresses, at the exterior of the south aisle wall, lend structural support and considerable interest to the design.

A steep pitched slate roof covers the nave and transept, and at the west end terminates in a striking gabled wall. This rich masonry facade is supported by heavy buttresses opposite the nave walls, and contains two tall narrow pointed windows and a small rose window. A very handsome pointed arched doorway is deeply revealed in its own gable. The recessed arches, within the deep reveal of this portal, spring from ornate caps supported by handsome dwarf columns, a very fitting entrance to this notable church. Occupying a corner lot, the church has a corner entrance with a small stone vestibule, opening to the south. With its steep pitched slate roof, it projects out from the side aisle adding a picturesque feature to the exterior of this handsome church.
